**Flood Control Project Maintenance  
Levee Inspections**

**Fall 2018 Levee Maintenance Deficiency Summary Report**

**Flood Control Project Maintenance  
Levee Inspections****LMA District Cover Sheet  
Fall 2018 Levee Inspection Results****Reclamation District No. 2103 Wheatland Vicinity**

**Reclamation District No. 2103 Wheatland Vicinity**

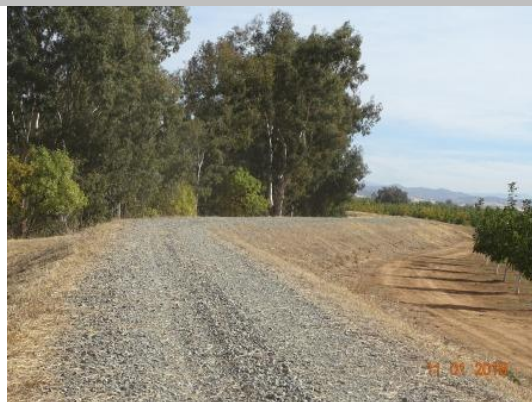
Photo 1 of 1 : FA\_2018\_RD2103\_10\_18\_20181107\_00042.jpg

View looking upstream landside of the annual vegetation that is well maintained, Fall 2018.

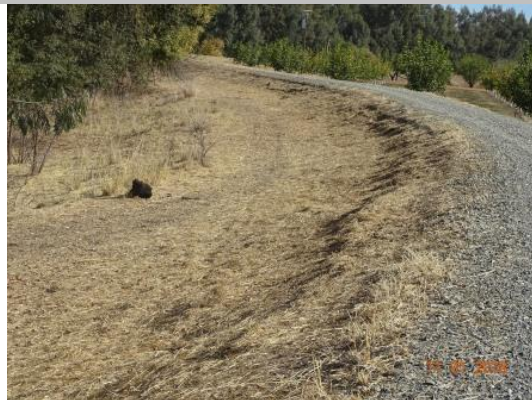
Photo 1 of 1 : FA\_2018\_RD2103\_10\_19\_20181107\_00041.jpg

View looking upstream waterside of the annual vegetation that is well maintained, Fall 2018.

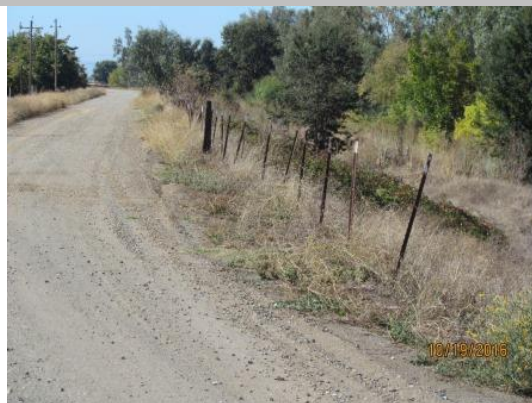
Photo 1 of 1 : FA\_2018\_RD2103\_10\_11\_20180918\_00001.jpg

LM Start	0.01	Rating **	M	Issue No.	11
LM End	0.47	Issue Type +	En	Location *	WS
Category	Earthen Levee			GPS Latitude/Longitude	
				Start	End
Item	Encroachments			39.019849 °	39.021775 °
				-121.453871 °	-121.445642 °
DWR ID	DWR_RD2103_01_f_2013_11				
Comment Code					
FE : Fence					
Inspector Comment					
Fence along waterside hinge point.

View of fence along waterside hinge point looking downstream, still exists.

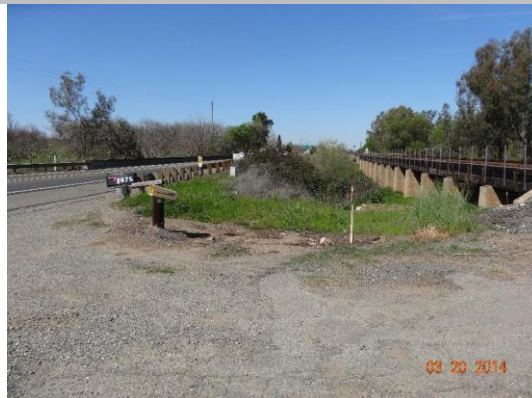
Photo 1 of 3 : UCIP\_FA\_2018\_39985\_69852.jpg

Comment Code					
Inspector Comment					
FS_ID:39985 DS_ID:19468 EP_NO: 3659 Repair Type: Non-Urgent Crossing Status: Indicator Found UCIP Comments: 03/04/2014 Need to contact owner to determine status of crossing. Need date of last inspection and confirmation that crossing is still in operable condition. It appears this is the same line as the next entry however, permit calls for Southern Pacific Pipe Lines, Inc as the owner and the sign found in the field indicates Kinder Morgan as owner. Need to contact owner to clarify if 2 crossings exist or if crossing is same owner will need to update permit information. (O. Magana - DWR UCIP) FIELD_STRUCT_DESC: 8.625-inch steel fuel line through the levee, 3 feet below the crown. Cutoff wall around pipe at centerline of levee. Pipe extends through overflow area. Markers visible on both sides. (8.625-inch authorized under Permit No. 3659, 1961-Southern Pacific Pipelines, Inc.) [Additional Reference(s): DWR Levee Logs, 2005. USACE Sacramento O&M Manual Unit No. 146, November 1962, (HLM 0.55)] FS Date: 3/20/2014

Marker visible on toe in between railroad tracks and highway (north).

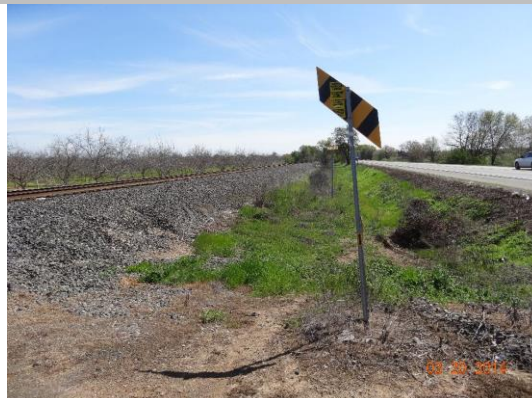
Photo 2 of 3 : UCIP\_FA\_2018\_39985\_69851.jpg

Marker visible on toe in between railroad tracks and highway (south).

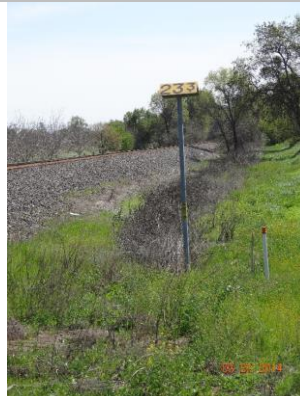
Photo 3 of 3 : UCIP\_FA\_2018\_39985\_69853.jpg

Marker visible on toe in between railroad tracks and highway (south).

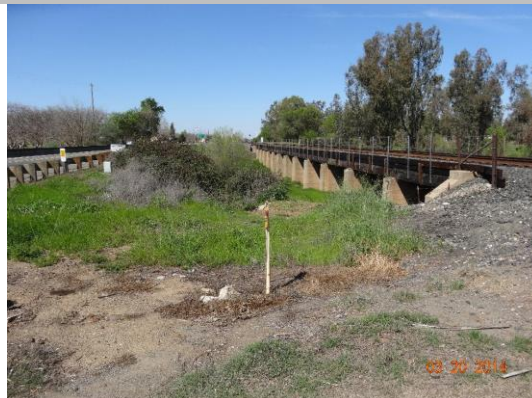
Photo 1 of 3 : UCIP\_FA\_2018\_39986\_71882.jpg

Comment Code						
Inspector Comment						
FS_ID:39986 DS_ID:24878 EP_NO: N/A Repair Type: Non-Urgent Crossing Status: Indicator Found UCIP Comments: It appears this is the same line as the next entry however, permit calls for Southern Pacific Pipe Lines, Inc as the owner and the sign found in the field indicates Kinder Morgan as owner. Need to contact owner to clarify if 2 crossings exist or if crossing is same owner will need to update permit information. Also need to contact owner to determine status of crossing. Need date of last inspection and confirmation that crossing is still in operable condition. FIELD_STRUCT_DESC: Kinder Morgan line through levee. Markers visible on both banks. FS Date: 3/4/2014

View of marker visible on waterward side (between HWY 65 and railroad).

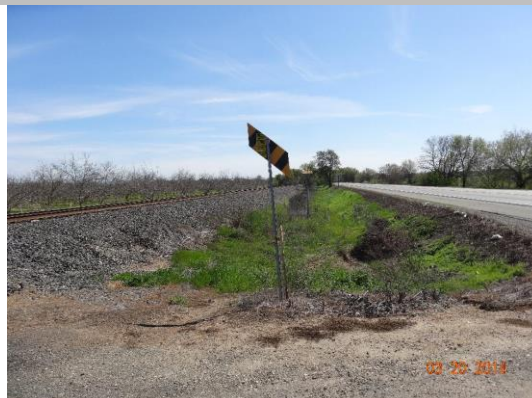
Photo 2 of 3 : UCIP\_FA\_2018\_39986\_71881.jpg

Markers visible on landward side.

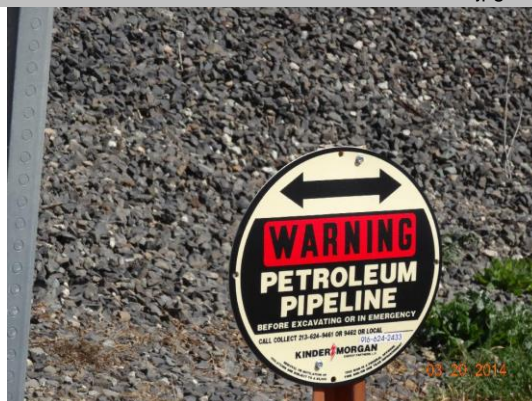
Photo 3 of 3 : UCIP\_FA\_2018\_39986\_71880.jpg

Petroleum Pipeline owned by Kinder Morgan.

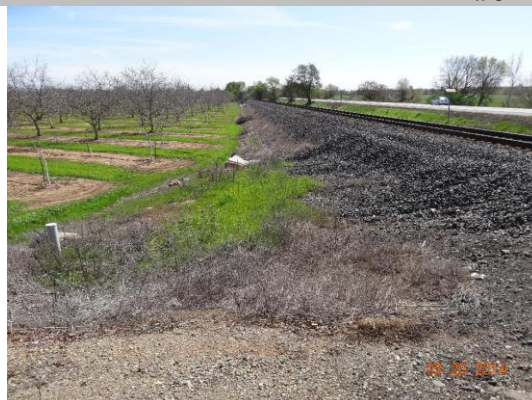
Photo 1 of 1 : UCIP\_FA\_2018\_43823\_73340.jpg

LM Start	0.55	Rating **	M	Issue No.	31
LM End	0.55	Issue Type +	En	Location *	
Category	Supplemental			GPS Latitude/Longitude	
				Start	End
Item	DWR UCIP Field Study			39.022654 °	39.022654 °
				-121.444665 °	-121.444665 °
DWR ID	19467				
Comment Code					
Inspector Comment					
FS_ID:43823 DS_ID:19467 EP_NO: 16041 Repair Type: Non-Urgent Crossing Status: Indicator Found UCIP Comments: 03/18/2015 Needs markers at levee crossing. (W. Wylie - DWR UCIP) FIELD_STRUCT_DESC: 2-inch steel communication conduit encasing telephone cable through the levee, 2-feet below the crown. Extends to junction box 10-feet from landside (LS) toe, parallel to railroad tracks. (communication conduit authorized under Permit No. 16041, 1993-Pacific Bell). [Additional Reference(s): DWR Levee Logs, 2005] FS Date: 3/18/2015

Junction box visible on LS toe (at lower left of photo).

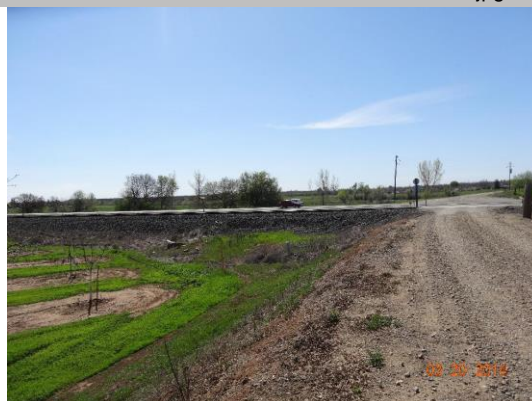
Photo 1 of 3 : UCIP\_FA\_2018\_39987\_71885.jpg

LM Start	0.56	Rating **	M	Issue No.	32	
LM End	0.56	Issue Type +	En	Location *		
Category	Supplemental			GPS Latitude/Longitude		
				Start	End	
Item	DWR UCIP Field Study			39.022665 °	39.022665 °	
				-121.444688 °	-121.444688 °	
DWR ID	24879					
Comment Code						
Inspector Comment						
FS_ID:39987						
DS_ID:24879						
EP_NO: N/A						
Repair Type: Non-Urgent						
Crossing Status: Indicator Found						
UCIP Comments: 03/04/2014 Need to contact owner to obtain depth of line through levee. Also need permit authorizing conduit through levee. (O. Magana - DWR UCIP)						
FIELD_STRUCT_DESC: Conduit line through levee. Markers visible on both sides.						
FS Date: 3/4/2014

View of landward side.

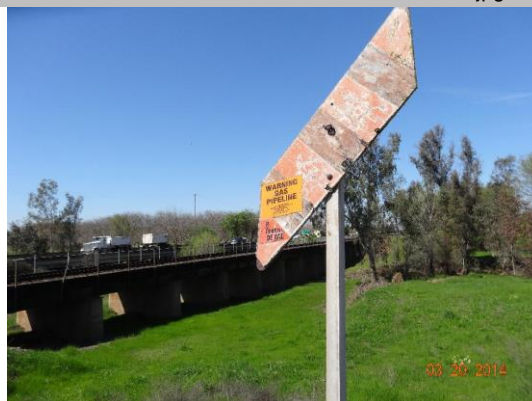
Photo 2 of 3 : UCIP\_FA\_2018\_38323\_69859.jpg

Marker visible waterward side.

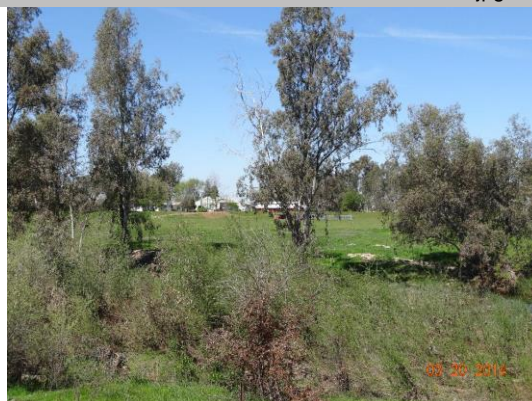
Photo 3 of 3 : UCIP\_FA\_2018\_38324\_69862.jpg

Overview of gas marker visible on opposite bank.

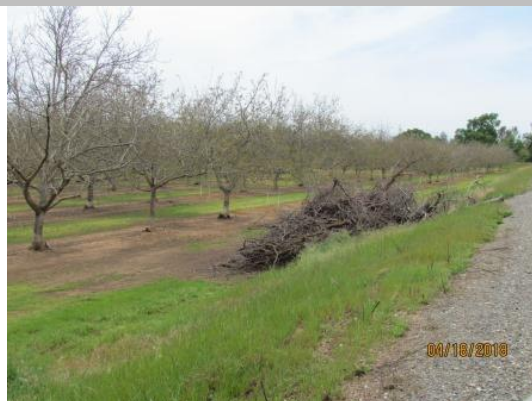
Photo 1 of 1 : FA\_2018\_RD2103\_10\_27\_20180918\_00006.jpg

LM Start	0.78	Rating **	M	Issue No.	27
LM End	0.78	Issue Type +	En	Location *	LS
Category	Earthen Levee			GPS Latitude/Longitude	
				Start	End
Item	Encroachments			39.024546 °	39.024546 °
				-121.441396 °	-121.441396 °
DWR ID	DWR_RD2103_01_s_2017_27				
Comment Code					
PR : Prunings					
Inspector Comment					
Pruning's on landside levee slope, Fall 2018.

View looking downstream landside of prunings on the levee slope.

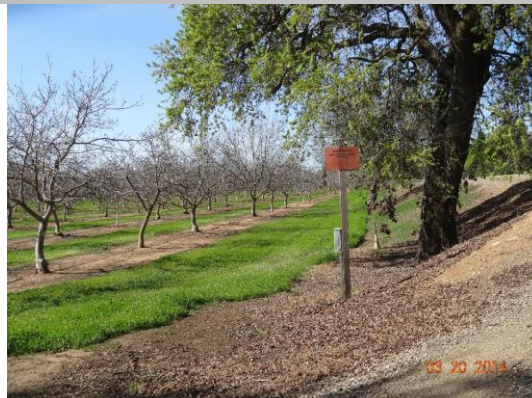
Photo 1 of 3 : UCIP\_FA\_2018\_39988\_71890.jpg

LM Start	0.81	Rating **	M	Issue No.	35
LM End	0.81	Issue Type +	En	Location *	
Category	Supplemental			GPS Latitude/Longitude	
				Start	End
Item	DWR UCIP Field Study			39.024725 °	39.024725 °
				-121.440978 °	-121.440978 °
DWR ID	24880				
Comment Code					
Inspector Comment					
FS_ID:39988					
DS_ID:24880					
EP_NO: N/A					
Repair Type: Non-Urgent					
Crossing Status: Indicator Found					
UCIP Comments: 03/04/2014 No marker found on waterward side-- need to confirm with owner if crossing goes through levee. If so, need depth of crossing through levee. Also need to obtain permit number used to authorize crossing. (O. Magana - DWR UCIP)					
FIELD_STRUCT_DESC: Conduit line through levee of unknown material or depth below the crown. Marker visible on landside (LS).					
FS Date: 3/4/2014

Underground cable line marker visible on landward side toe.

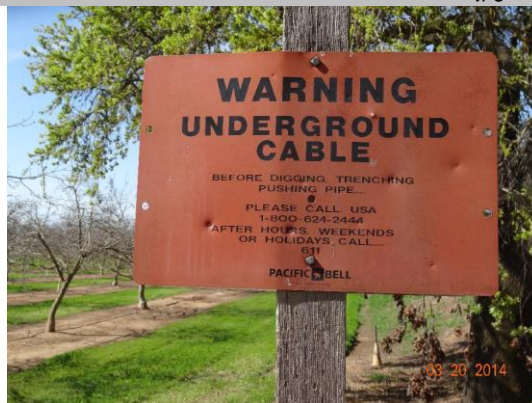
Photo 2 of 3 : UCIP\_FA\_2018\_39988\_71889.jpg

Marker is for underground cable line owned by Pacific Bell.

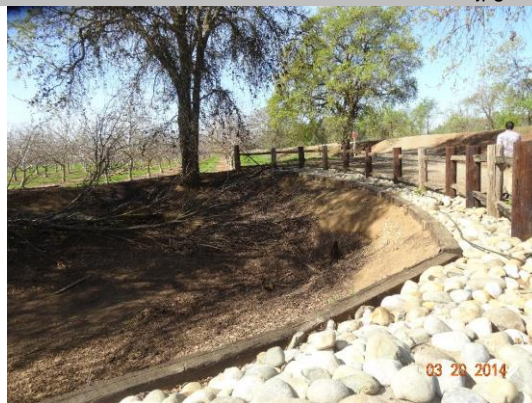
Photo 1 of 3 : UCIP\_FA\_2018\_38325\_69869.jpg

LM Start	0.82	Rating **	A/W	Issue No.	36
LM End	0.82	Issue Type +	Ma	Location *	
Category	Supplemental			GPS Latitude/Longitude	
				Start	End
Item	DWR UCIP LMA Responsibility			39.024811 °	39.024811 °
				-121.440750 °	-121.440750 °
DWR ID	19471				
Comment Code					
Inspector Comment					
FS_ID:38325 DS_ID:19471 EP_NO: N/A Repair Type: No Action Needed Crossing Status: Found UCIP Comments: FIELD_STRUCT_DESC: 36-inch corrugated metal drainage pipe through the levee, 14.4 feet below the crown. Concrete headwall, flap-gate, and 3-foot by 6-foot concrete splash apron located on the waterside (WS) toe. Outfall drain from old Grasshopper Slough. [Additional Reference(s): DWR Levee Logs, 2005. USACE Sacramento O&M Manual Unit No. 146, November 1962, (HLM 0.83)] FS Date: 3/20/2014

View of CMP crossing located on landward side.

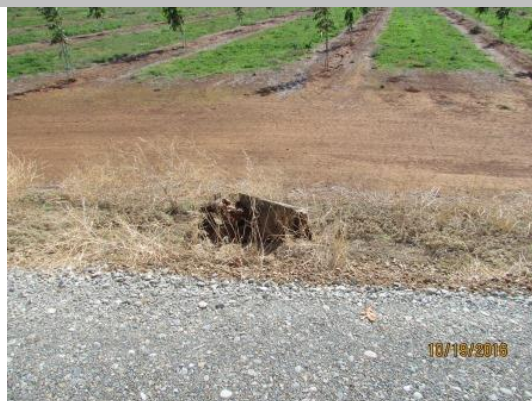
Photo 1 of 1 : FA\_2018\_RD2103\_10\_26\_20180918\_00005.jpg

View of tree stump on lanside levee slope. Fall 2016, still exist as of Fall 2018.

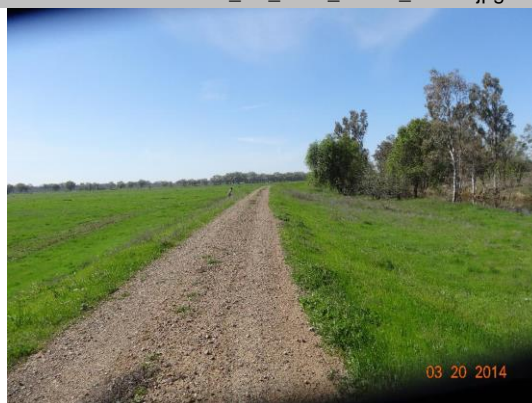
Photo 1 of 3 : UCIP\_FA\_2018\_41183\_69917.jpg

Comment Code					
Inspector Comment					
FS_ID:41183 DS_ID:19473 EP_NO: 1886 Repair Type: Non-Urgent Crossing Status: Indicator Found UCIP Comments: 03/20/2014 Need to coordinate with owner. Severely corroded section of steel pipe present on waterward side--no other evidense present at this location. Owner will need to coordinate with CVFPB and DWR-Inspector to determine proper action to abandon crossing. (O. Magana - DWR UCIP) FIELD_STRUCT_DESC: *ABANDONED* 12-inch steel irrigation pipe through the levee, 3.1 feet below the crown. Siphon breaker on the waterward slope. Concrete standpipe at the landward toe. Vertical pump on waterside (WS). Open on WS end. Permit includes gravel dam through channel of Dry Creek. Crossing is angled 45 degrees. (10-inch pipe authorized under Permit No. 1886, 1959-R. H. Blackford, Jr.) [Additional Reference(s): DWR Levee Logs, 2005. USACE Sacramento O&M Manual Unit No. 146, November 1962, (HLM 1.86)] FS Date: 3/20/2014

Overview of levee crown.

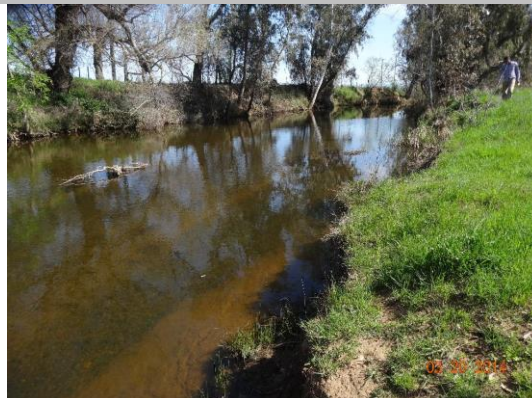
Photo 3 of 3 : UCIP\_FA\_2018\_38327\_69879.jpg

No crossing visible on waterward side.

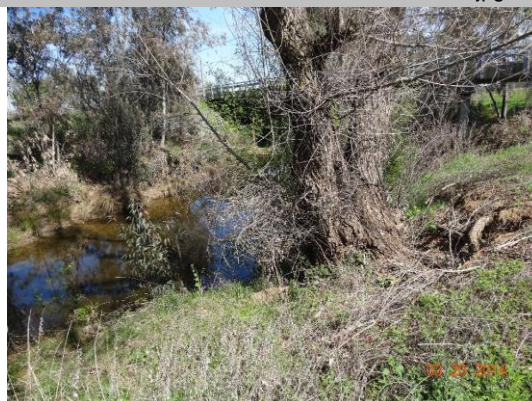
Photo 2 of 3 : UCIP\_FA\_2018\_38331\_69893.jpg

Crossing was not visible on waterward side.

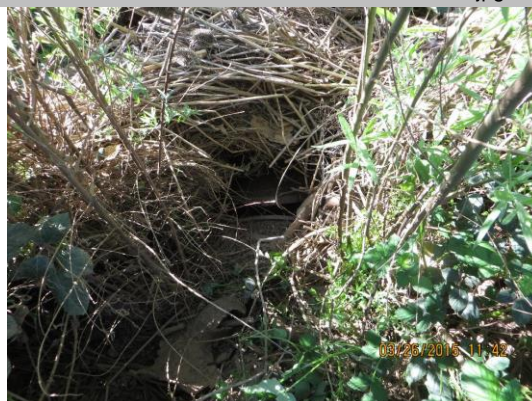
Photo 1 of 3 : UCIP\_FA\_2018\_53435\_73429.jpg

Flapgate at WS berm blocked by soil and vegetation buildup.

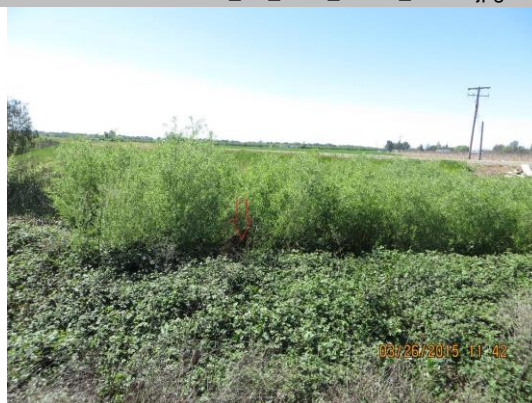
Photo 2 of 3 : UCIP\_FA\_2018\_53435\_73428.jpg

Location of pipe and flapgate on WS berm.

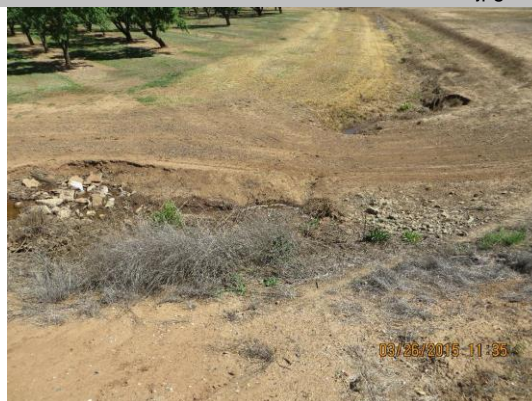
Photo 3 of 3 : UCIP\_FA\_2018\_53435\_73427.jpg

Pipe visible at LS toe.

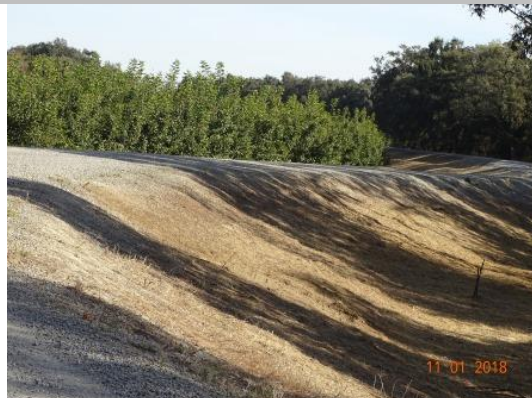
Photo 1 of 1 : FA\_2018\_RD2103\_11\_13\_20181107\_00032.jpg

View looking upstream waterside of the annual vegetation that is well maintained, Fall 2018.

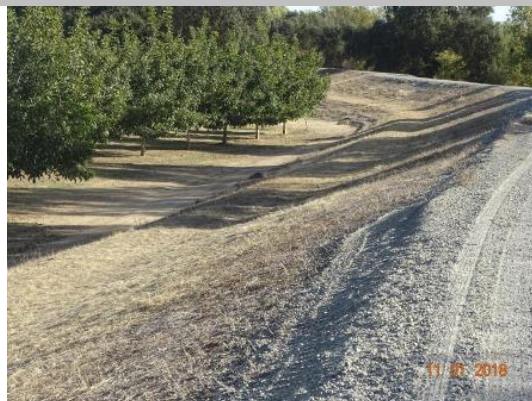
Photo 1 of 1 : FA\_2018\_RD2103\_11\_11\_20181107\_00033.jpg

View looking upstream landside of the annual vegetation that is well maintained, Fall 2018.

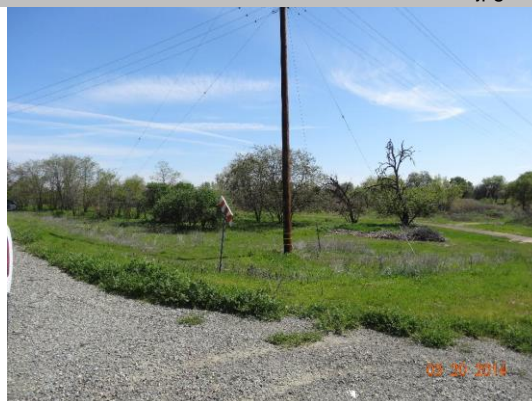
Photo 1 of 2 : UCIP\_FA\_2018\_39992\_69914.jpg

Marker visible on waterward side.

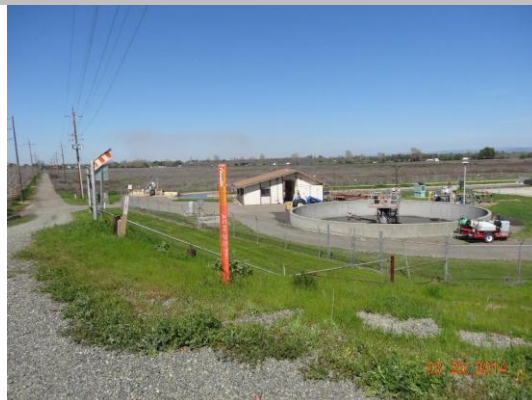
Photo 2 of 2 : UCIP\_FA\_2018\_39992\_69913.jpg

Marker visible on landward side.

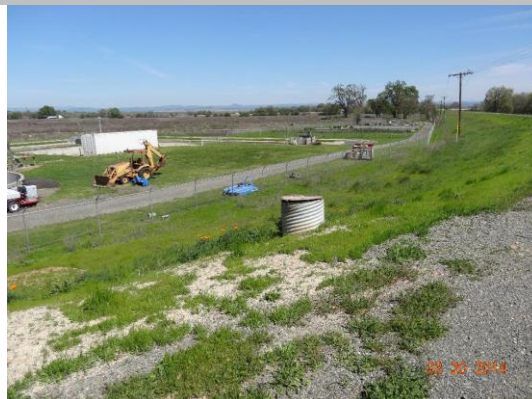
Photo 2 of 2 : UCIP\_FA\_2018\_39993\_69911.jpg

CMP riser located on landward side.

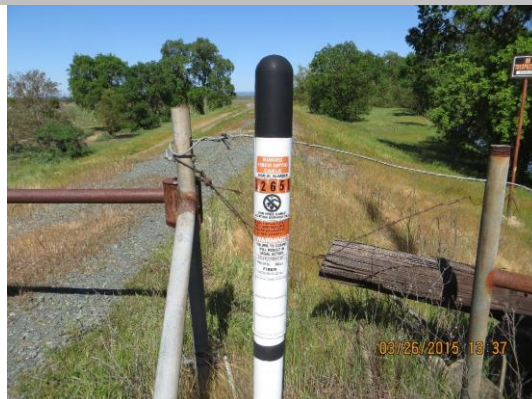
Photo 1 of 3 : UCIP\_FA\_2018\_44089\_73568.jpg

Fiberoptic line marker on crown of levee

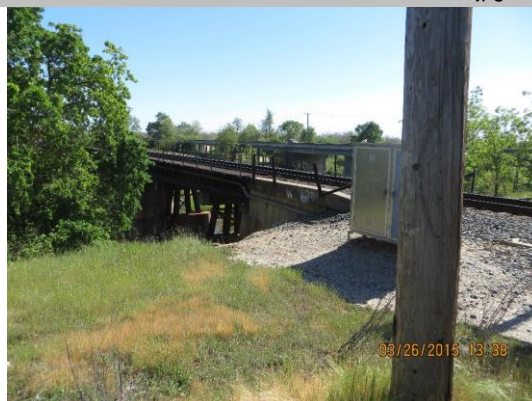
Photo 2 of 3 : UCIP\_FA\_2018\_44089\_73567.jpg

6-inch steel conduit visible on upstream side of railroad bridge.

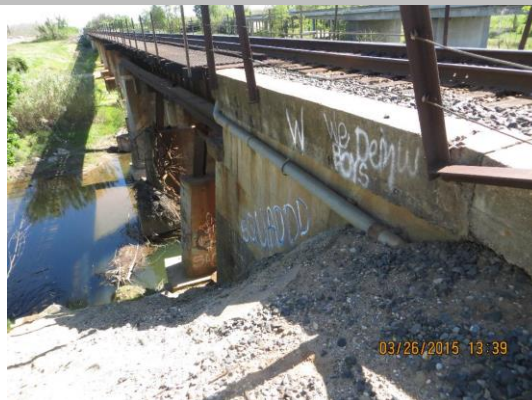
Photo 3 of 3 : UCIP\_FA\_2018\_44089\_73566.jpg

6-inch steel conduit visible on upstream side of railroad bridge.

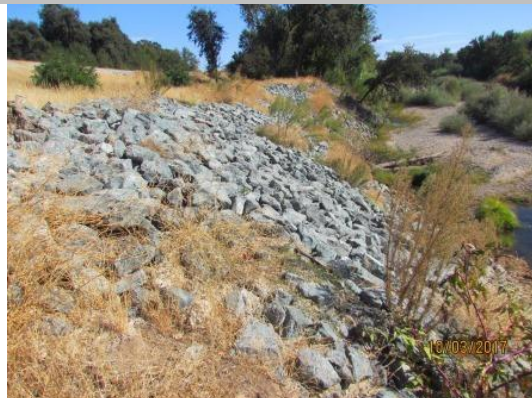
Photo 1 of 5 : FA\_2018\_RD2103\_11\_12\_20180918\_00001.jpg

Photo taken at time of Fall 2017 Levee Inspection, looking upstream at the erosion site.

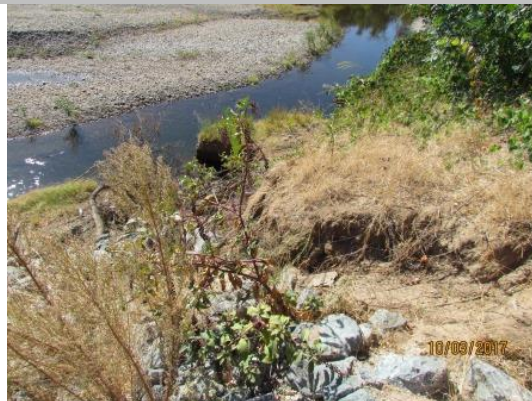
Photo 2 of 5 : FA\_2018\_RD2103\_11\_12\_20180918\_00002.jpg

Photo taken at time of Fall 2017 Levee Inspection, looking upstream at the erosion site.

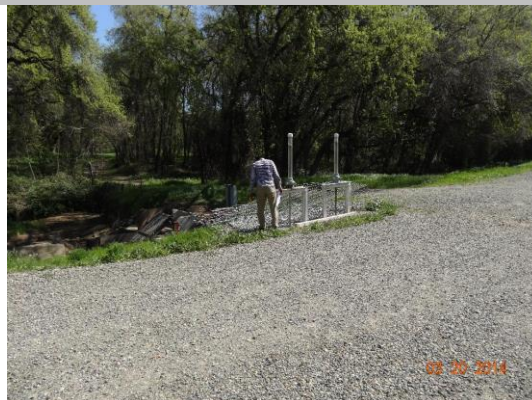
Photo 2 of 3 : UCIP\_FA\_2018\_40045\_71907.jpg

Slide gates visible located on landward side.

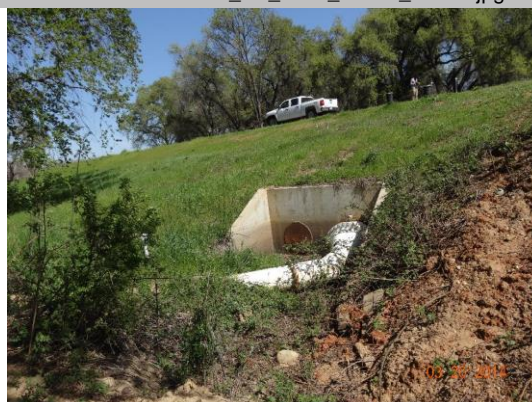
Photo 3 of 3 : UCIP\_FA\_2018\_40046\_71919.jpg

Concrete headwall visible on waterward side--white pipe attached to crossing at headwall.

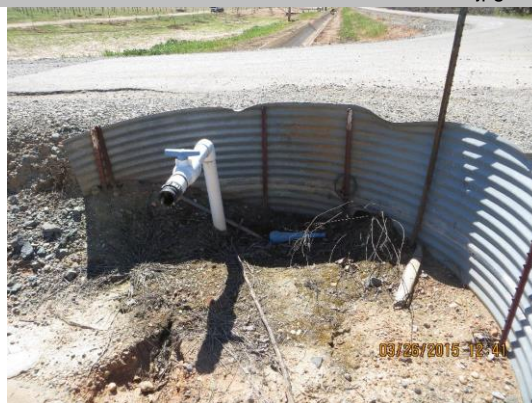
Photo 1 of 2 : UCIP\_FA\_2018\_43957\_73435.jpg

Service connection and ball valve visible on LS shoulder.

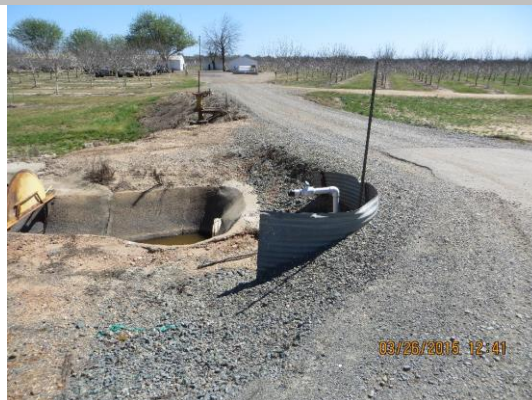
Photo 2 of 2 : UCIP\_FA\_2018\_43957\_73434.jpg

Service connection and ball valve visible on LS shoulder.

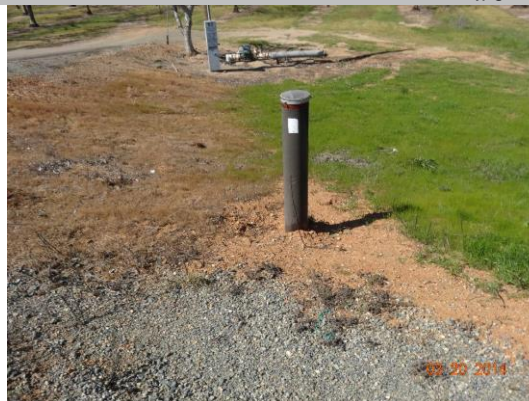
Photo 2 of 3 : UCIP\_FA\_2018\_40048\_71921.jpg

Riser located on landward slope.

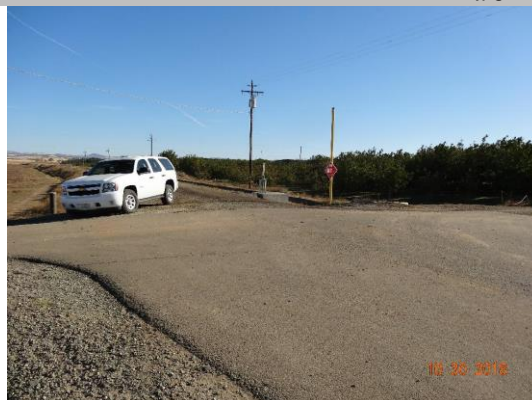
Photo 2 of 2 : UCIP\_FA\_2018\_53438\_78445.jpg

No signs of crossing are visible at approximate location.

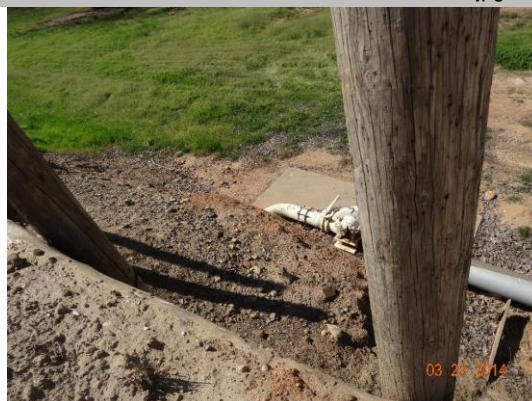
Photo 1 of 3 : UCIP\_FA\_2018\_40049\_71928.jpg

Pipe visible on waterward side.

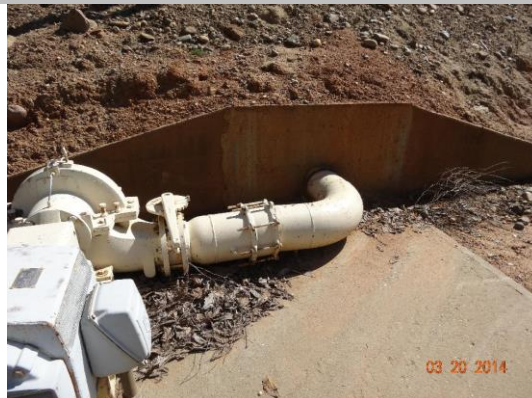
Photo 3 of 3 : UCIP\_FA\_2018\_40049\_71932.jpg

Pipe connection at crossing.
